Repair of DC converter generator BV25 and BGC1

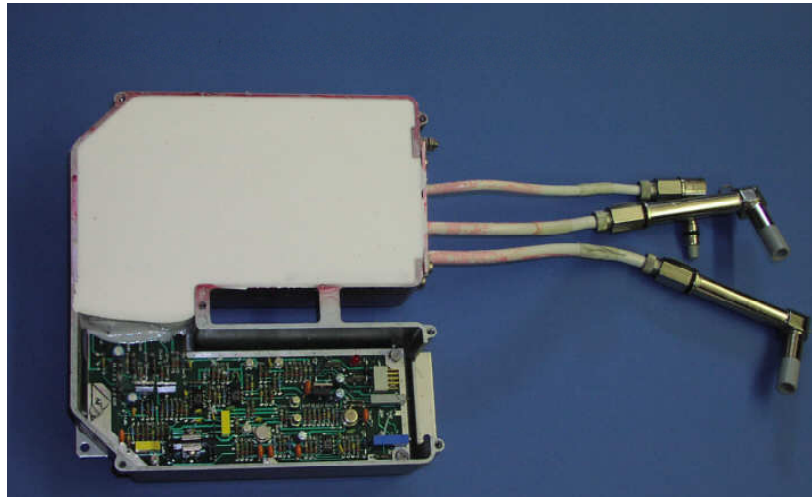
Use: The high-energy units are a components of X-ray units

Error-description: Because of dissolution of potting it comes to electric flashovers and the destruction of components.

Error correction: The old potting compound is removed completely. For the determination of defective parts is carried out under strongly lowered high voltage is a function check. After repair, the product is poured and conducted a new audit function under operating conditions.
